## **DEBRIS EXAMINATION REPORT**

### **SAFETY INVESTIGATION FOR MH370**

**Malaysia Airlines MH370 Boeing B777-200ER (9M-MRO)  
08 March 2014**

**Identification of Debris (Item 18 in the “Summary of Possible MH370 Debris Recovered”) recovered from Antsiraka beach, Madagascar on 12 June 2016**

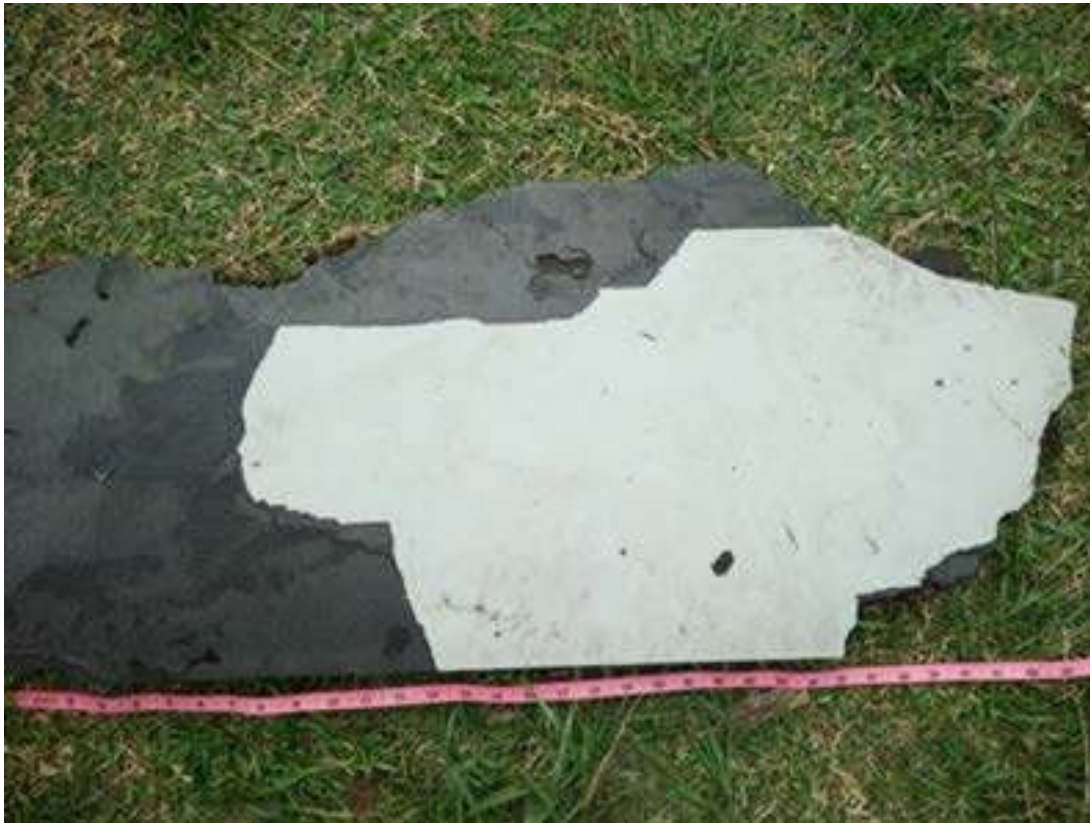
This item was recovered from Antsiraka beach, Madagascar on 12 June 2016. The part is identified as Item No 18 of the items found; refer to the “*Summary of Possible MH370 Debris Recovered*”.
